JAMESVILLE RESERVOIR DAM

ONONDAGA COUNTY, NEW YORK
INVENTORY NO.418

PHASE I INSPECTION REPORT
NATIONAL DAM SAFETY PROGRAM

Prepared by: TIPPETTS-ABBETT-McCARTHY-STRATTON

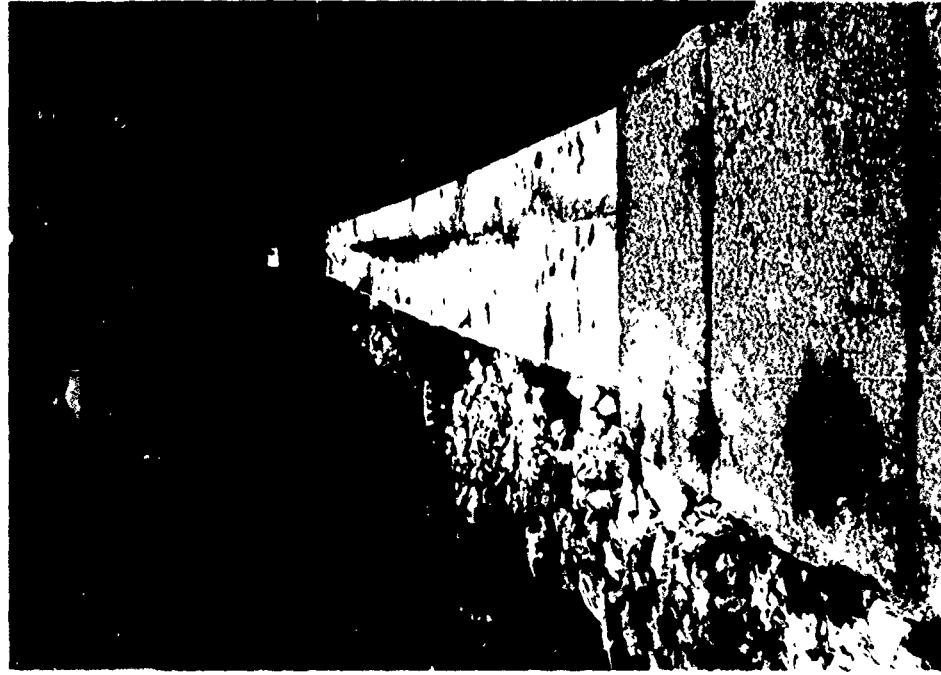
Leakage from between the two top courses of stone on the spillway is visible on the downstream face.

SHUTTLE CREST SHOWING DISPLACEMENT DOWNSTREAM
OF TOP COURSES OF STONE.

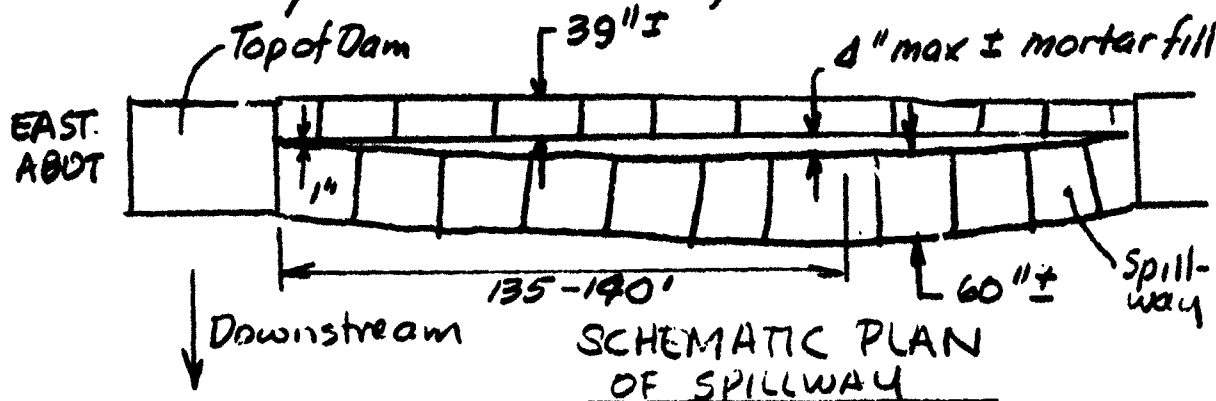
Max downstream (D/S) movement of downstream stones approximately 9"-10" occurs 135-140 ft west of East limit of spillway. Gap between U/S and D/S stones filled with mortar; stones were reported to be pinned in place after movement.
